CONSERVATION DEPARTMENT

Condition & Treatment Report

Object: [1959.2363] Figure, Bird (eagle)

Creator Name: Wilhelm Schimmel

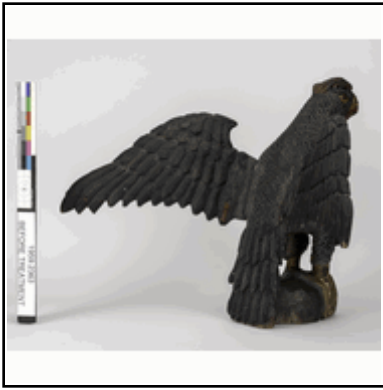
1959.2363 OR NL BT 11 2018

The proper left wing of the eagle appears to have been accidentally knocked or pushed out of

place, possibly by a visitor, according to the Change in Condition form. The finger joints that attach the wing to the body are intact, but have been pushed out of alignment. Small areas of gesso have been lost along the joint on both the front and back of the eagle.
