CONSERVATION TREATMENT RECORD

Student name: Madeline Hagerman

Object name: Glass

Brief descriptor: Commemorative toasting goblet

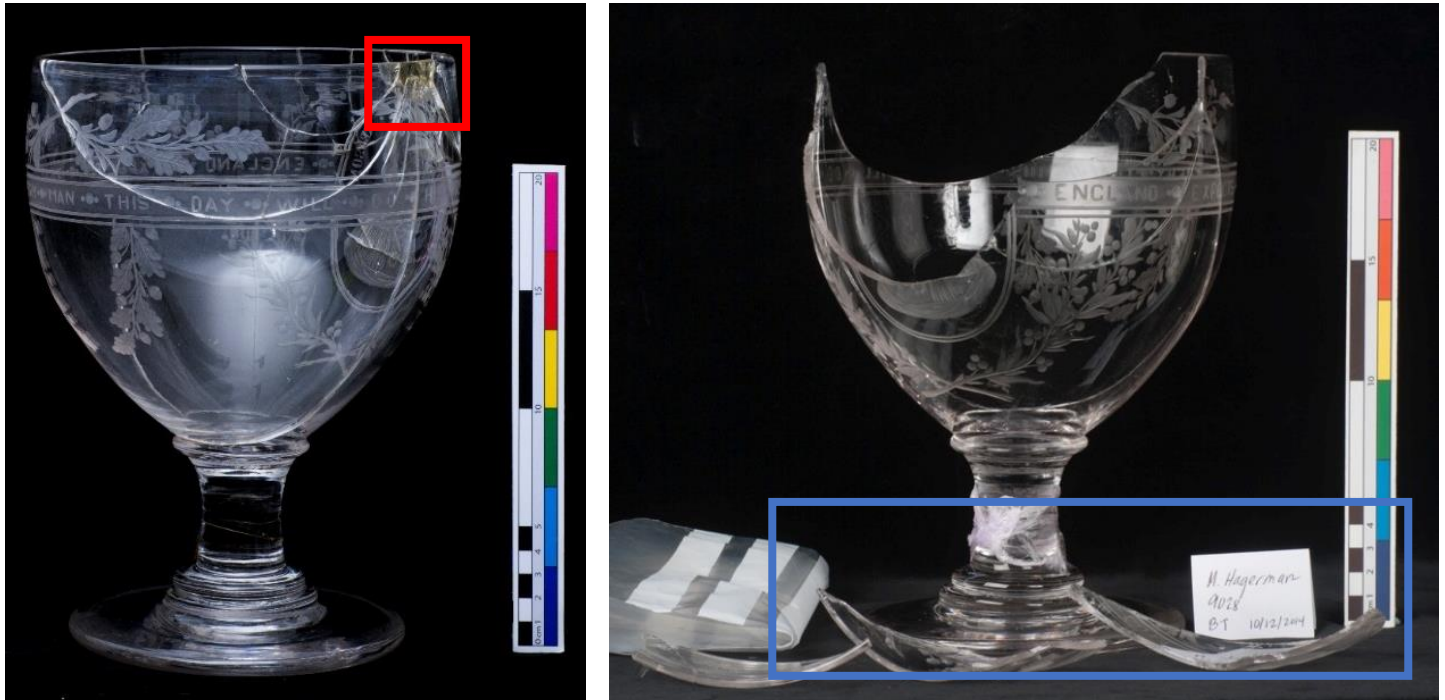
Figure 2. Glass before treatment 2013 (Burke 2014; left) and before treatment 2014 (Hagerman 2014; right).

The main damage to the vessel is structural. It is currently in about 32 useable fragments with many small chips and glass dust. It appears as if the goblet was dropped or hit against the rim to the right of Nelson's portrait, as fractures radiate from this point. There are also many hairline cracks visible throughout the bowl and in the larger fragments. HXTAL NYL-1 is adhered to the joint surfaces of many of the fragments.

The object came into the conservation lab in 2013 in one piece (Figure 2, left). It had been reconstructed with a yellowing adhesive and fill (Figure 2, red). The previous conservator made the decision to take down the joins and re-adhere them with HXTAL NYL-1, an epoxy resin that is yellowing-resistant and matches the refractive index of glass. Unfortunately, during the reconstruction process it became apparent that the HXTAL was contaminated and Burke had to take down the

During careful handling for photography and examination, two large pieces of the glass which had been adhered with contaminated HXTAL NYL-1 [Hydrogenated Bisphenol A : diglycidal ether polyoxypropylene triamine] in 2013/2014 detached from the body (Figure 2, right, blue). This is particularly worrying, because after reviewing Burke’s treatment record, she states that about 75% of the vessel was reconstructed as of June 2014 with uncontaminated HXTAL NYI-1

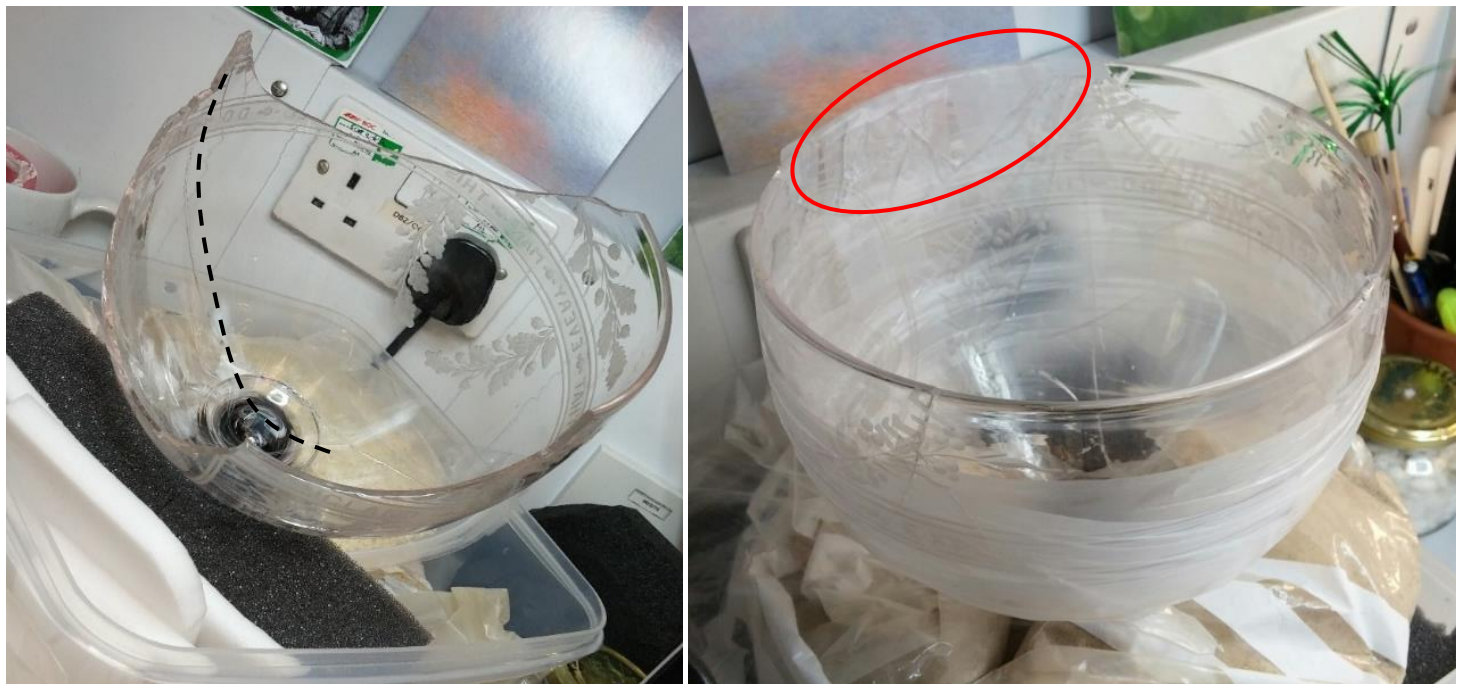
Figure 3. Phases of reconstruction. Phase 1 (left) and phase 2 (right).

As the object was being photographed on 10/12/2014, a large piece fell off (Figure 2, right image). This was the first sign that perhaps the previous conservator had not accomplished as much reconstruction as had been stated in the treatment record. Approximately a week later, half of the bowl of the vessel broke off from the base. After cleaning, the object was put together in two phases.

- Phase 1 (Figure 3, left) involved joining the two large halves of the glass vessel (Figure 3 left, dashed line)
- Small pieces of Magic Tape (pressure sensitive tape) were applied as “sutures” on the outside of the vessel to hold the glass together during reconstruction.
- The half with the base attached was laid down on a piece of Plastazote (polyethylene foam) cut to support the curve of the bowl
- Sand bags were added to stop the glass from moving during curing
- Tiny drops of HXTAL NYL-1 were applied to the joint surface on the inside of the glass with a Number 2 size silicone brush
- The glass was allowed to cure for the recommended 7 days before the tape was taken off and excess HXTAL removed

- Phase 2 (Figure 3, right) involved joining the remaining 30 pieces to the reconstructed base
- The glass was stood on its base, cushioned with sand bags to ensure the two large halves were secure
- Small pieces of Magic Tape were applied as “sutures” on the join surface of the larger pieces on the outside of the vessel--Full-size pieces of Magic Tape were used on the outside of the glass as a backing for the tiny, smashed fragments (Figure 3 right, red)
- Tiny drops of HXTAL were applied to all join edges on the inside of the glass using a small silicone brush
- Parafilm (thermoplastic paraffin film) was wrapped around the glass and held in place with Magic Tape to counteract springing that occurred when the glass initially broke

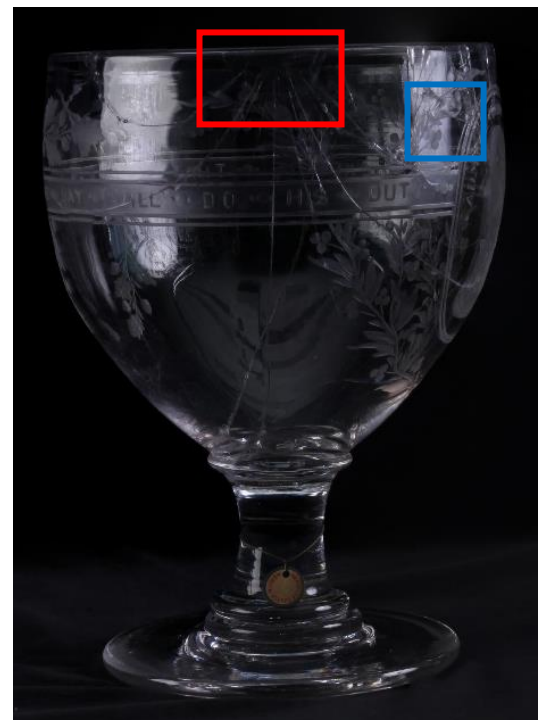
Figure 5. Image indicating HXTAL fills on the glass.

Two large areas of loss required fills. While they improved the aesthetic appearance of the vessel, they also imparted structural stability. Large fills (Figure 5, a and b) were accomplished using silicone moulds. Each week the vessel was rotated to add more HXTAL into either fill a or fill b. Small chips and areas of loss were filled purely for aesthetic reasons.

- Tiranti quick-set T40 (two-part thixotropic silicone) was cast on an area of the rim with no decoration for fill a
- A second application of the silicone was used to seal the mould onto the glass

- The glass was laid on its side at a high angle on a Plastazote support with sand bags to fill the rim of the fill
- HXTAL was added to the join using a silicone brush

- 4 further applications of HXTAL were required, each with the glass at a slightly lower angle, to bring the level of the fill up to that of the surrounding glass

- After drying for over a week the fill was polished using first a Number 15 scalpel to remove bumps and surface irregularities, then Micromesh (abrasive paper) in grades 2400, 4000, 6000, 8000, and 12000. A leather chamois was used to give a final polish

- Even after polishing, the fills were not transparent. To correct for this, a thin layer of HXTAL was applied as a finish with a silicone brush. This made the surface transparent.

- The mould for fill b was accomplished by fitting white modelling wax into the area to be filled. This was shaped to the exact surface and incised elements, creating a precise fill
- This mould was sealed with a second application of silicone and the glass was laid on its side with the area to be filled facing down
- HXTAL was added to the area to be filled
- 2 further applications of HXTAL were required to bring the fill up to the surface of the glass
- No polishing was necessary
