CONSERVATION DEPARTMENT

Condition & Treatment Report

Object: [1969.2121] Hasp

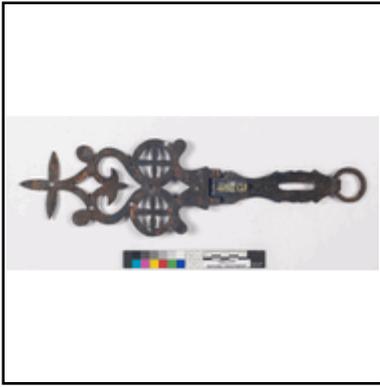
1969.2121 OR NL BT 07 2018

The metal surface appears stable but corroded under the paint layers. There is much more

corrosion on the reverse of the hasp where the paint has worn away.

The paint has worn away on the reverse of the hasp, exposing the corroded metal beneath.

There appears to be a passivating layer of corrosion products and dirt and grime below much of the extant paint. This is especially visible on the reverse of the hasp.

There are remnants of wood on the reverse of the hasp around one the nail holes on the reverse of the hasp.

There are remnants of white paint or plaster on the reverse of the hasp plate in two areas.

"G69.2121" is written in yellow paint to the reverse of the hasp over a clear isolating layer.
