## CONSERVATION DEPARTMENT

### *Condition & Treatment Report*

**Objects:** [1969.4722.002 through 1969.4722.026] 25 Tiles, Fireplace or wall tile mounted in Bertrand Fireplace

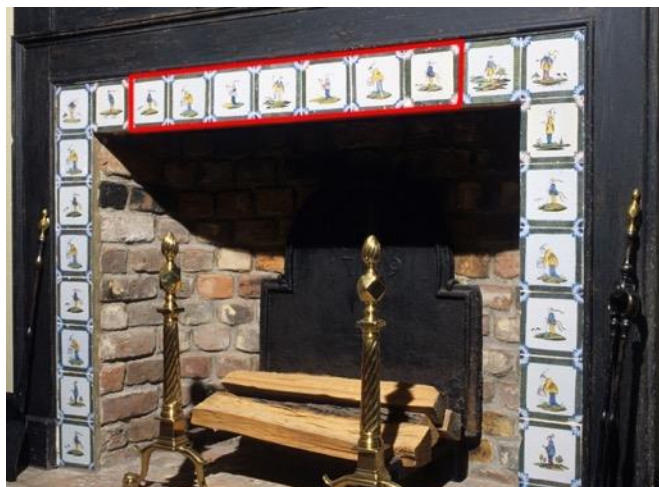
*Figure 1. Bertrand fireplace, red rectangle shows the area where the plaster mounting material has become detached from the steel support beam.*

1 - Plaster mounting material of top row of tiles was reattached to the steel support beam using a 3:1 mixture of 40% Paraloid B-72 w/v in 9:1 acetone:denatured alcohol : 40% Paraloid B-48N w/v in 9:1 acetone:denatured alcohol slightly bulked with 3M Glass Bubbles. The adhesive was injected behind the plaster using a syringe.

2 – The tiles were clamped in place with Mylar between the clamps and the tile to prevent abrasion to the tiles' surfaces for 24 hours until all solvent had evaporated.

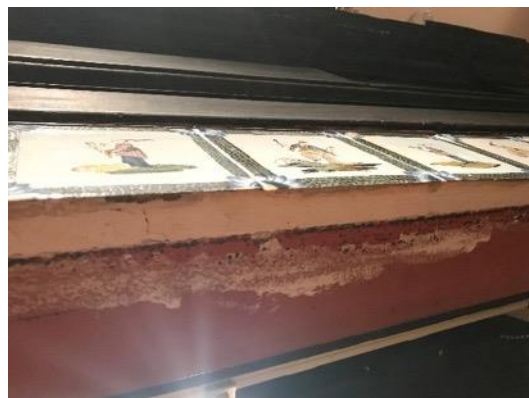
Overall, the main concern with Bertrand fireplace is structural. The plaster holding the top row of the tile surround to the underlying steel structural support has become detached, especially in the center of the row (Figure 2). When touched, the top row of tiles moves freely from the steel support. This presents a potential hazard. If the plaster behind any more tiles becomes detached from the steel support, they may fall from the fireplace surround.

*Figure 2. Detail of steel bar (red) and thick plaster behind the top row of tiles where it has become detached and cracked.*

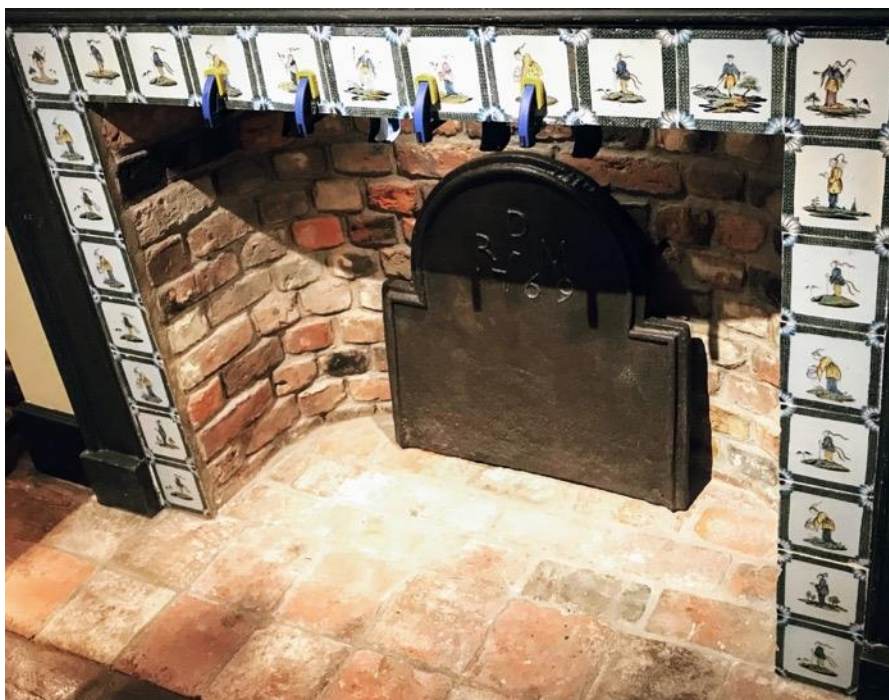
*Figure 3. Top panel of tiles is clamped in place after injection of adhesive.*

1 - Plaster mounting material of top row of tiles was reattached to the steel support beam using a 3:1 mixture of 40% Paraloid B-72<sup>5</sup> : 40% Paraloid B-48N<sup>6</sup> w/v in acetone bulked with 3M Glass Bubbles.<sup>7</sup> The addition of Paraloid B-48N to Paraloid B-72 raises the glass transition temperature (T<sub>g</sub>) of the mixture and imparts greater strength to the adhesive.<sup>8</sup> The glass microballoons eased the gap-filling nature of the adhesive and the workability of the mixture, as it was injected upside down to the small space between the plaster and steel.

2 – The panel was clamped into place with Irwin Quick-Grip clamps padded with Volara<sup>9</sup> over silicone release Mylar to prevent abrasion to the tiles’ surfaces for 48 hours until all solvent has evaporated.
