CONSERVATION TREATMENT RECORD

Student name: Madeline Hagerman

Object name: Glass

Brief descriptor: Commemorative toasting goblet

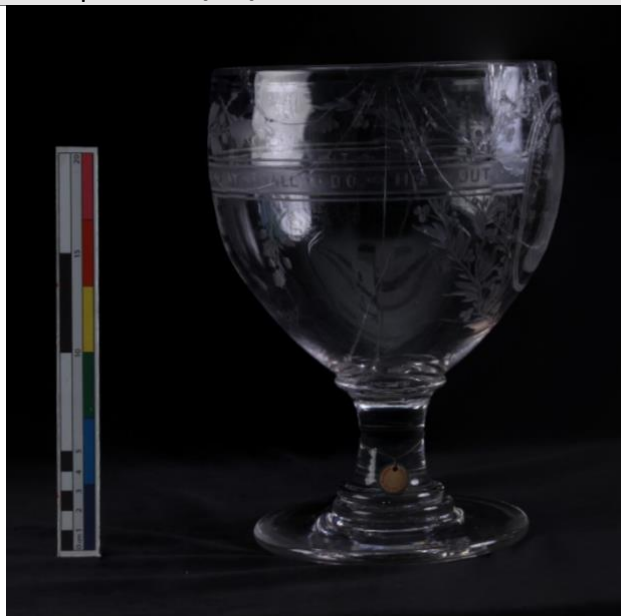
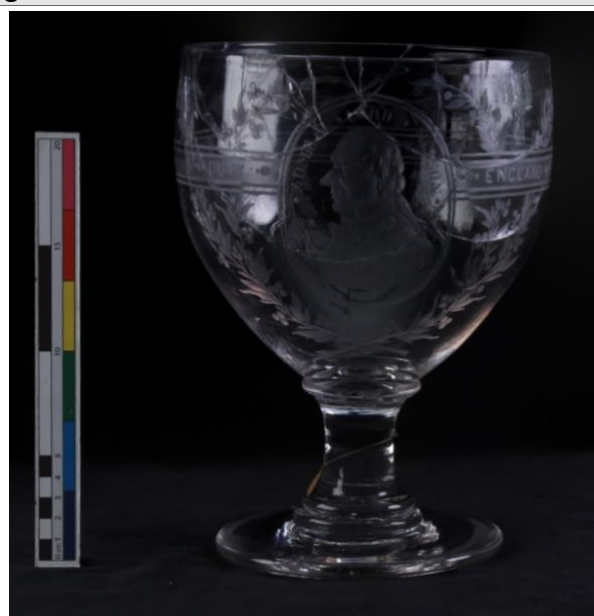
The main damage to the vessel is structural. It is currently in about 32 useable fragments with many small chips and glass dust. It appears as if the goblet was dropped or hit against the rim to the right of Nelson's portrait, as fractures radiate from this point. There are also many hairline cracks visible throughout the bowl and in the larger fragments. HXTAL NYL-1 is adhered to the joint surfaces of many of the fragments.
